Proceedings of 7th Windsor Conference: *The changing context of comfort in an unpredictable world* Cumberland Lodge, Windsor, UK, 12-15 April 2012. London: Network for Comfort and Energy Use in Buildings, <http://nceub.org.uk>

Why advanced buildings don't work?

Paul Gerard Tuohy, Gavin B Murphy

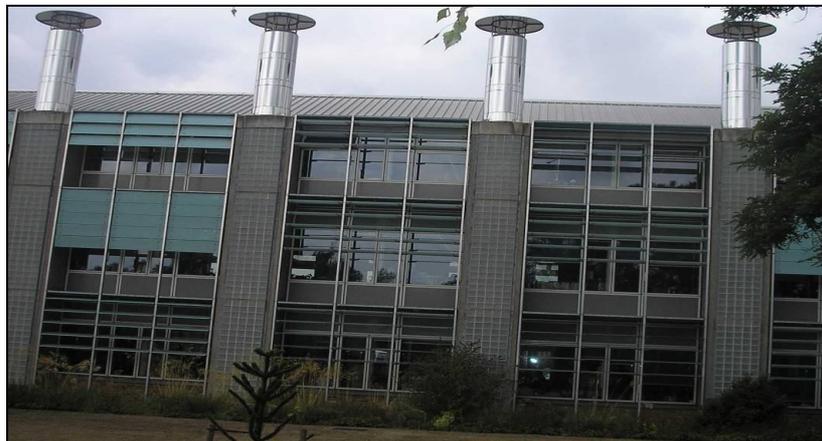
The Environmental Office building is an assisted naturally ventilated (ANV) office building over three floors situated in Garston, England (figure 1). It was intended as an exemplar for future buildings and is still frequently identified as an example to be followed (RAE 2010).

Figure 1. Environmental Office.

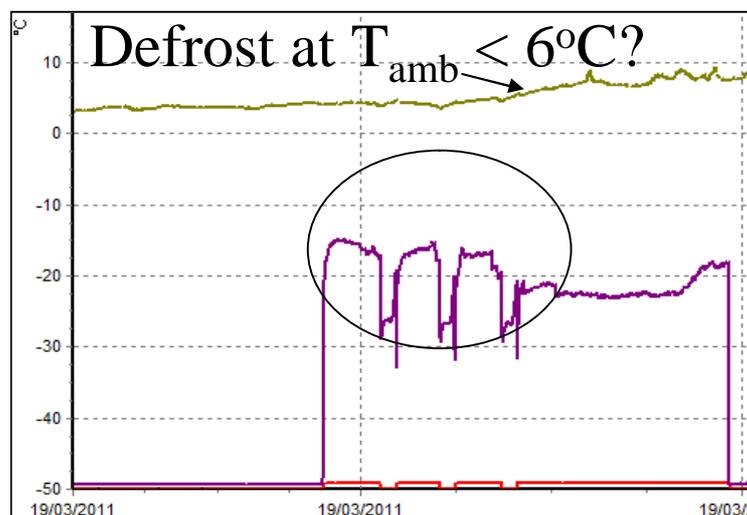
Figure 2. Air source heat pump performance showing defrost at 4 to 5°C.

There were many interesting observations and potential improvements these include:

- For optimal heat pump performance there should be a large delta T across the tank (i.e. good stratification).
- The system was programmed to sterilise (for legionella) the tank every 4th heat pump cycle which meant that at random times (approximately twice a day) the entire tank was heated to 60°C, significantly reducing heat pump performance.
- The energy spent defrosting the outdoor unit was significantly higher and reduced the unit output more than expected (up to 25% rather than the 10% expected). Defrost energy use was a maximum at outdoor temperatures of 5°C and high humidity i.e. normal Scottish conditions (figure 2).
- The overall COP observed was around 2 compared to the predicted performance of 3.
- The electricity used was at a standard rather than off peak tariff, negating the financial benefit of reduced electricity use.
